Structural Rehabilitation Under Severe Access Constraints

Brendan O'Sullivan, PE | Consor

Jerry Barnett, PE | Clark Regional Wastewater District

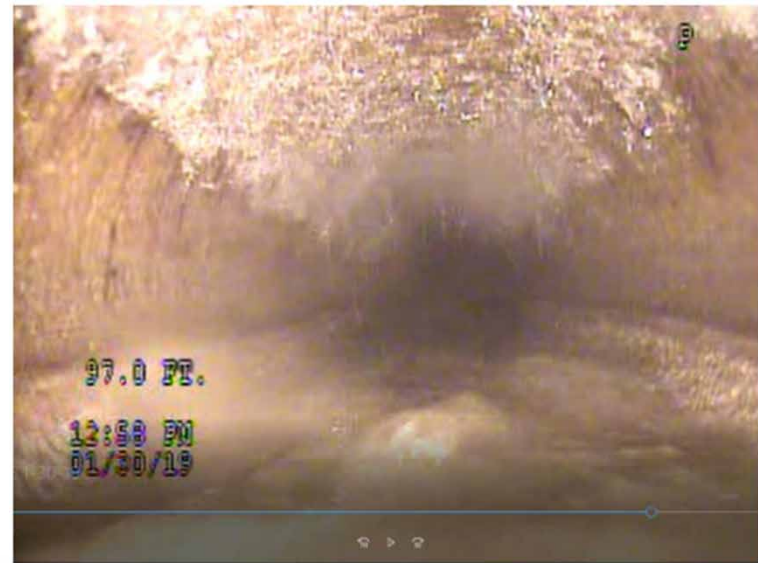
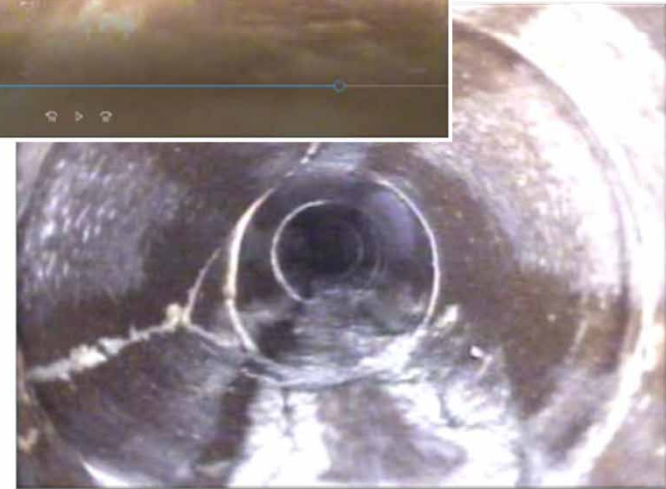
Condition Assessment - Results

- PACP Grades 4 and 5
- Wall loose ½" to 1"
- Exposed reinforcement
- Cracking
